# San Fernando, California, Earthquake of February 9, 1971

LEONARD M. MURPHY  
*Scientific Coordinator*

*Volume I*

*Part B.* Buildings *continued*; Soils and Foundations

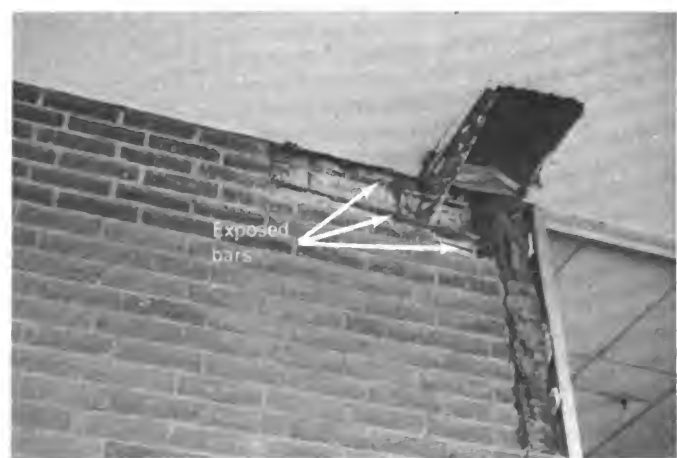
Figure 3.—Thriftmart Market. Strut connection to brick shear wall. Exposed are three No. 7 bars about 14 feet long. J. Kesler photograph.

into the masonry wall (fig. 1, section C-C). The bars lap with three No. 7 bars, placed at a lower elevation, that extend about 14 feet along the wall. This connection pulled loose, spalling the brick away from the length of the three No. 7 welded dowels, and vertically along the edge of the wall where a pipe column is embedded to support the vertical load of the girder (fig. 3). The failure appears to have been caused by a combination of bond and shear overload at the connection. Since the three continuous bars were placed below the welded dowel bars, the total load was transferred by shear through a net section of the wall.

Using the code seismic force level, the force at the connection, assuming half the tributary load went to each of the two wall segments, would be about 18,000 pounds; shear in the wall, assuming 3 feet 6 inches effective length, would be about 50 psi. The bond stress on the three bars would be 53 psi. These figures are approximate only because of the unknowns involved with relative stiffnesses of walls, struts, connections, direction of forces, and other factors that would affect distribution. From this analysis, it is evident that a connection failure should not occur until actual force levels reached several times the code force level. The damage was repaired by raising the three long bars and welding them directly to the three dowels. A continuous stress path thus was obtained, providing uniform force distribution over a longer length of wall.

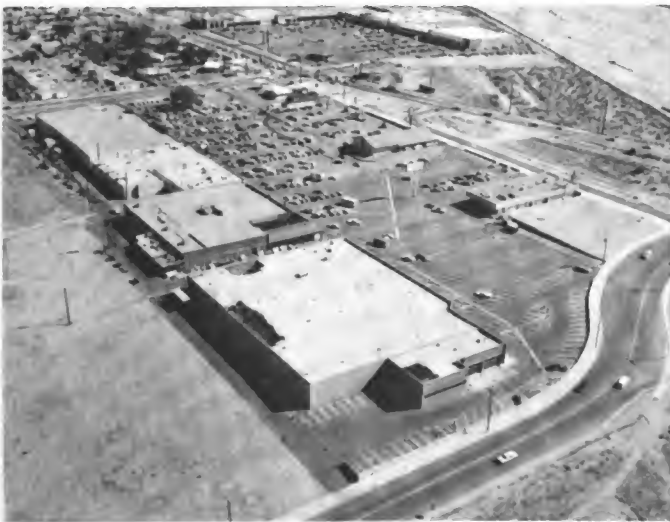
Figure 2.—W. T. Grants (foreground). Note three areas (dark) of roof collapse. Builder's Emporium (11) is just above W. T. Grants. Department of County Engineer photograph.

along the north wall for a length of about 145 feet, along the north wall of the west wing for about 50 feet, and along the east wall for a length of about 30 feet (figs. 2, 3, 4, and 5). In each of these areas the 4- by 16-inch or 6- by 16-inch purlins were framed perpendicular to the wall. The wall was forced out of plumb by as much as 8 to 9 inches. Several other areas of the roof diaphragm sustained cracked roofing and distorted plywood. An interior wood stud bearing wall supporting the mezzanine floor joists displaced and required repairs.

The concrete block walls were repaired by jacking them back into place in some areas, and by replacing them with new materials in other areas. Additional ledger bolts through the walls, with steel plate washers both inside and outside, were installed. Bolted continuity ties through the first girder line parallel to the walls were installed as part of the repair work.

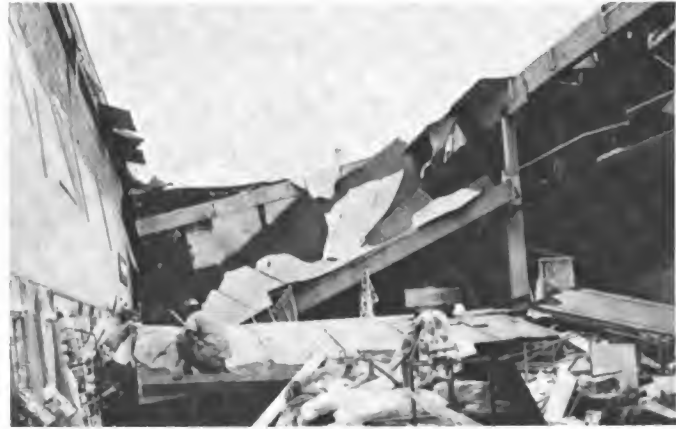
Figure 3.—W. T. Grants. Collapsed roof along north wall. J. F. Meehan photograph.

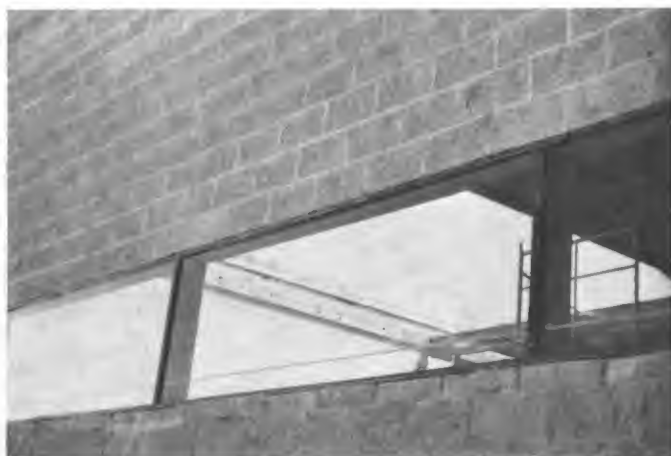
Figure 4.—W. T. Grants. Collapsed roof at west wing.  
J. Kesler photograph.

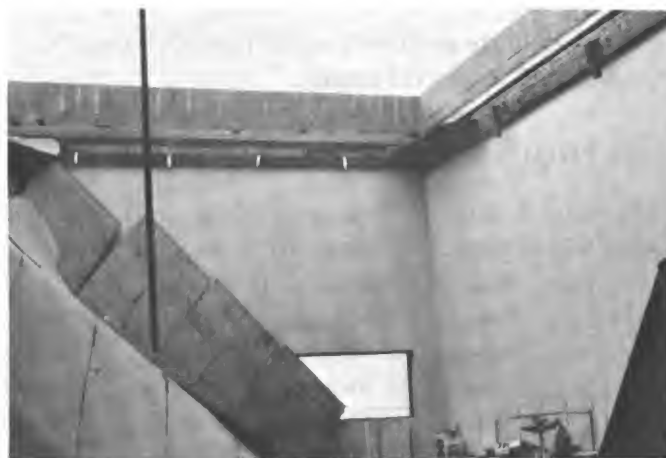
Figure 5.—W. T. Grants. Collapsed roof at west wing.  
J. F. Meehan photograph.

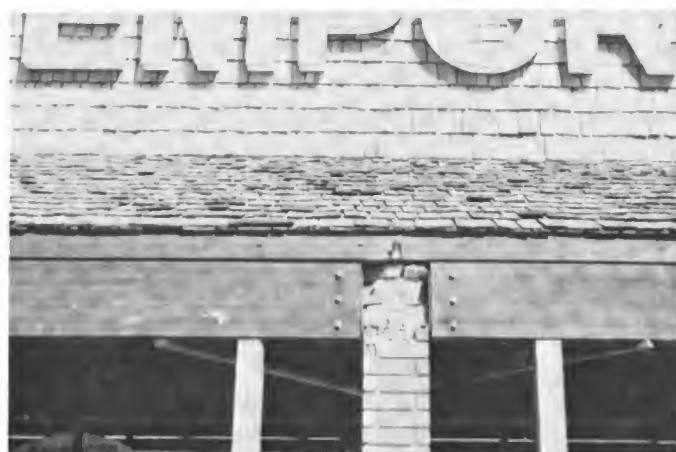
Girders (7 by 18 in.) along the south wall canopy line were loosened from their supports at the masonry columns at three locations (fig. 1, section D-D, and fig. 4). The seismic axial forces in the girders were large enough to fracture the masonry column by pull-out (tension) on the anchor bolts and by compression against the column face. The masonry was fractured and loosened to the extent that spalling occurred at the face of the column.

Figure 4.—Builder's Emporium. South wall girder connection with outside masonry spalled off. J. Kesler photograph.

The distressed portions of the roof structure were replaced with reinforced connections. The split ledgers were removed and replaced with bolts through the wall—plate washers on the outside wall face and at the inside ledger.

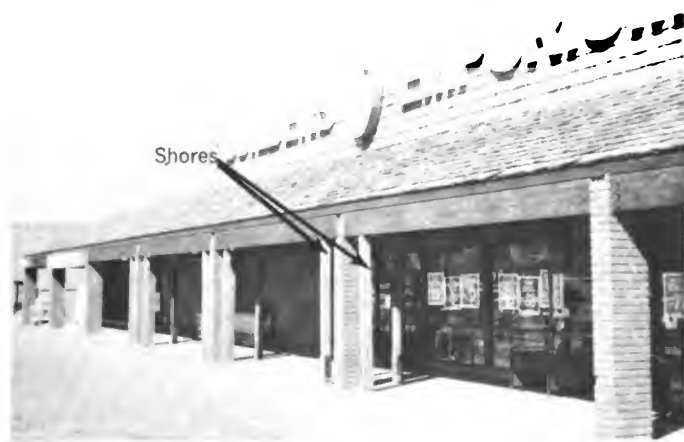
Figure 3.—Builder's Emporium. South wall. Note shores adjacent to columns. J. Kesler photograph.

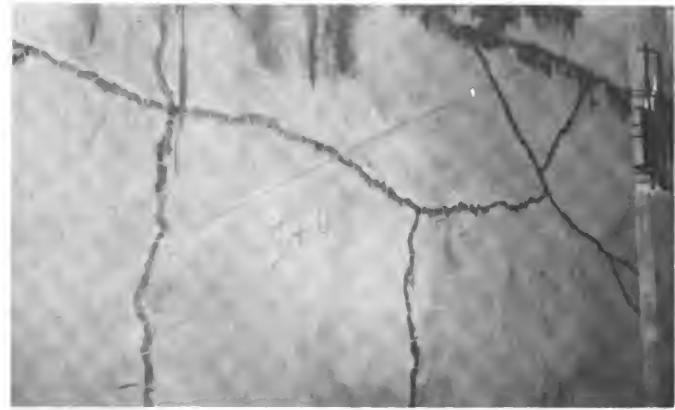
Figure 7.—Alpha Beta Market. Epoxy-patched cracks in precast concrete wall panel at line 6. Wheeler & Gray photograph.

Reinforced precast concrete panel walls were damaged extensively by cracking of the concrete. Even though the majority of the cracks were already repaired, they still were clearly visible (fig. 7). A definite pattern of cracking could not be detected, as the cracks occurred in vertical, horizontal, and diagonal directions. Some separation between the poured-in-place pilaster and the precast panels could be seen, but it could not be established if they were earthquake-induced or existed previously.

Pipe columns on line 4, leaning about 4 inches toward the east, were straightened during repairs. All cracked concrete walls were to be pressure injected with epoxy compound, and concrete pilasters were to be gunited after proper preparation of the affected area (fig. 9). Completion of structural work was to be followed by repair of architectural items such as finishes, ceilings, fixtures, and others.

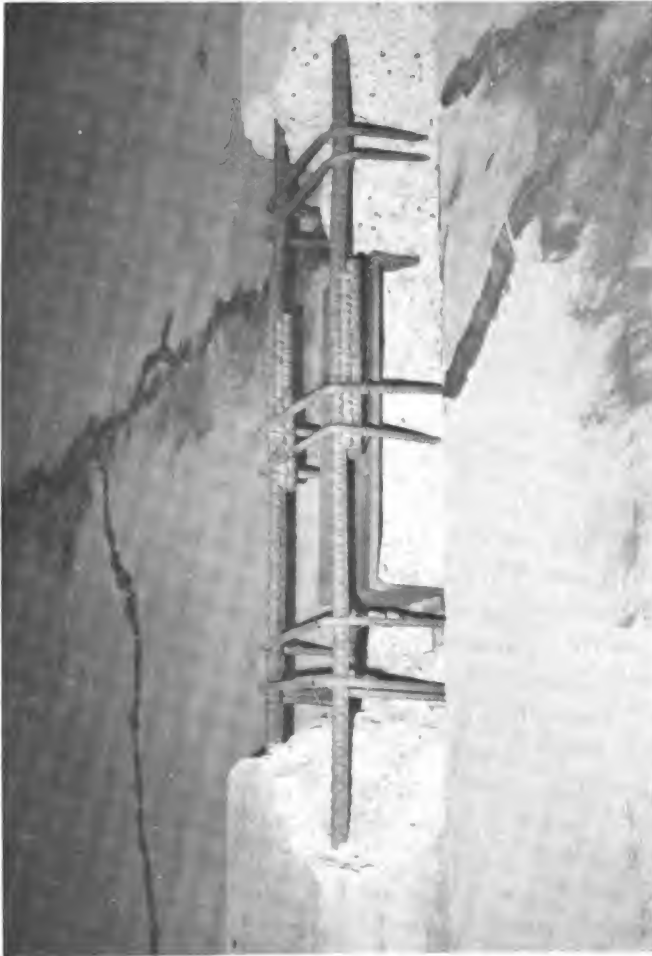
The poured-in-place concrete pilasters (wall columns), located between the precast wall panels, almost without exception suffered heavy damage at the points where the steel beams from the higher roof and the tapered steel girders from the lower roof connect to them (fig. 5, section 18-18). It is known that the girder anchor bolts were connected through 3-inch-long slotted holes, burned in the bottom flanges of the girders for erection purposes. Considerable movement between girders and wall pilasters undoubtedly contributed to the damage at these connections. Serious cracking and spalling of the concrete, which in some instances extended to adjacent panels, took place at those points (figs. 8, 9, and 10).

Figure 8.—Alpha Beta Market. End of tapered steel girder from adjacent lower roof. Wheeler & Gray photograph.

The effect of differential movements between two structures of different stiffnesses was clearly indicated by damage sustained to pilasters at connections with tapered steel girders from lower roofs (figs. 8, 9, and 10). Also, cracking of concrete wall was much more pronounced in side walls with adjacent lower buildings than in end walls, where no lower construction existed. As in other buildings investigated and cov-

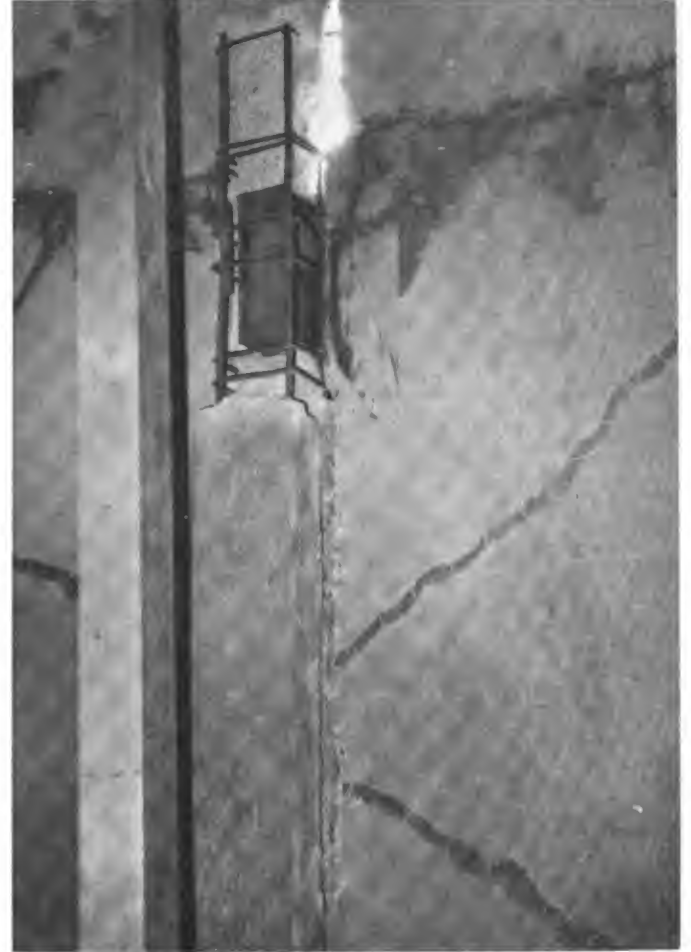
Figure 9.—Alpha Beta Market. Damage inflicted to wall and pilaster by end of tapered steel girder. Temporary shoring at left. Wheeler & Gray photograph.

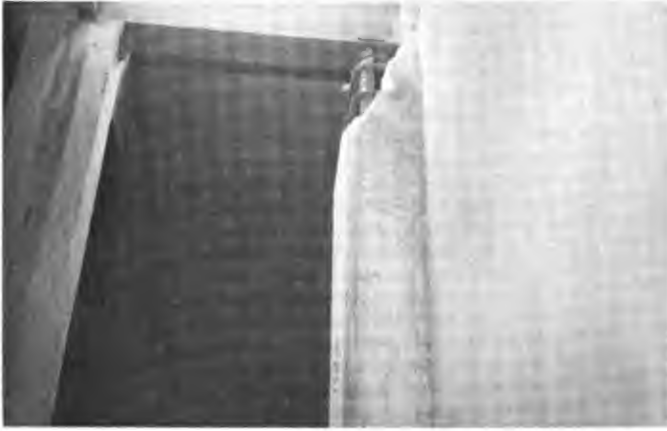
Figure 10.—Alpha Beta Market. Top of concrete pilaster at connection with steel beam. Wall line 6. Wheeler & Gray photograph.

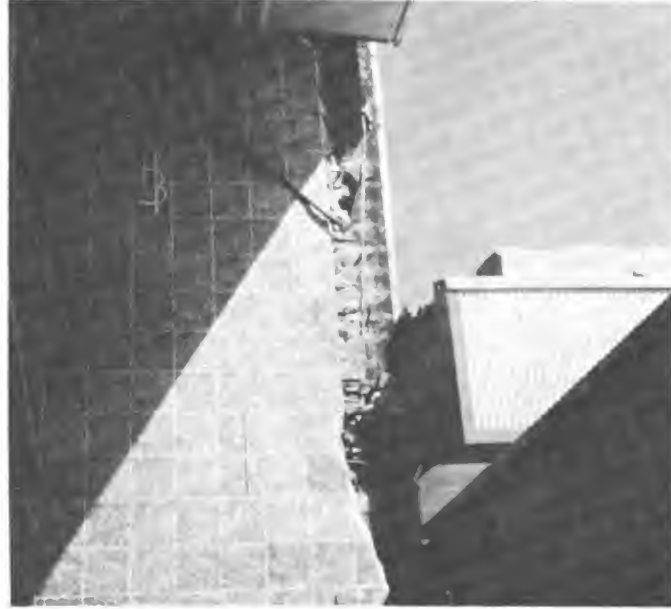
and partial breakage of bricks (figs. 11 and 12). The author was not able to see the walls since they had already been removed, but personal descriptions indicated that the major extent of the damage took place in the lower portions of the wall near the floor slab.

Figure 12.—Alpha Beta Market. Front (south) shear wall, looking east. D. F. Moran photograph.

The reinforced brick shear walls were removed completely and replaced by reinforced gunited con-

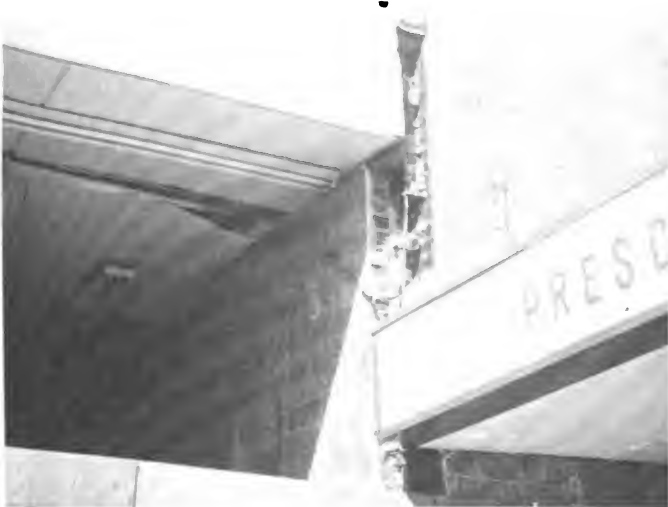
Figure 11.—Alpha Beta Market. Front (south) shear wall. D. F. Moran photograph.

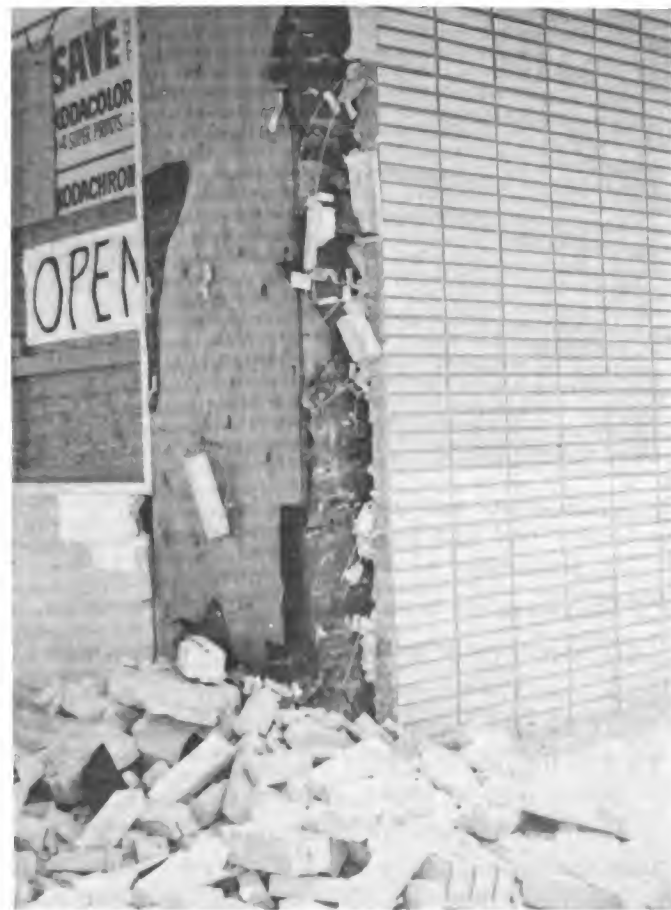
Figure 13.—Alpha Beta Market. Southeast corner of building east of market; brick veneer broke loose from its stud wall backing. Wheeler & Gray photograph.

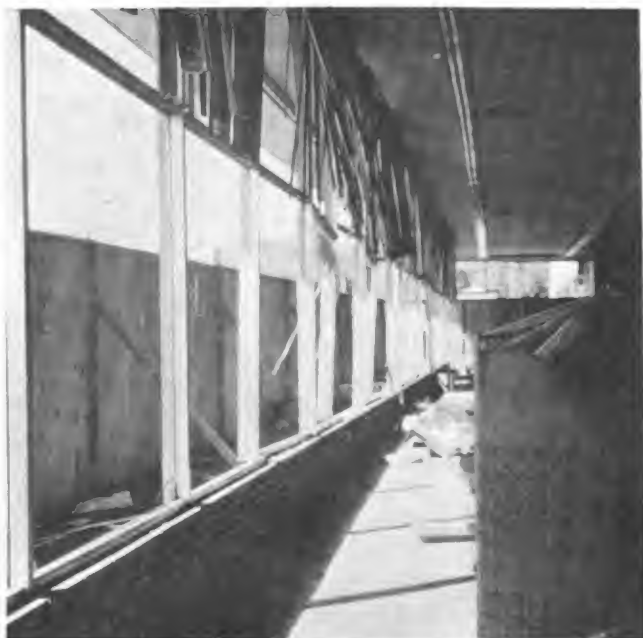
Widespread damage to nonstructural items occurred throughout the building. Most of the glass window wall at the front of the market cracked and collapsed (fig. 14). Acoustical tile soffits buckled and spalled off, wall finishes cracked, lighting fixtures broke loose from their supports and fell to the floor, and most of the market merchandise spilled from the shelves.

Figure 14.—Alpha Beta Market. Front (west) curtain wall. D. F. Moran photograph.

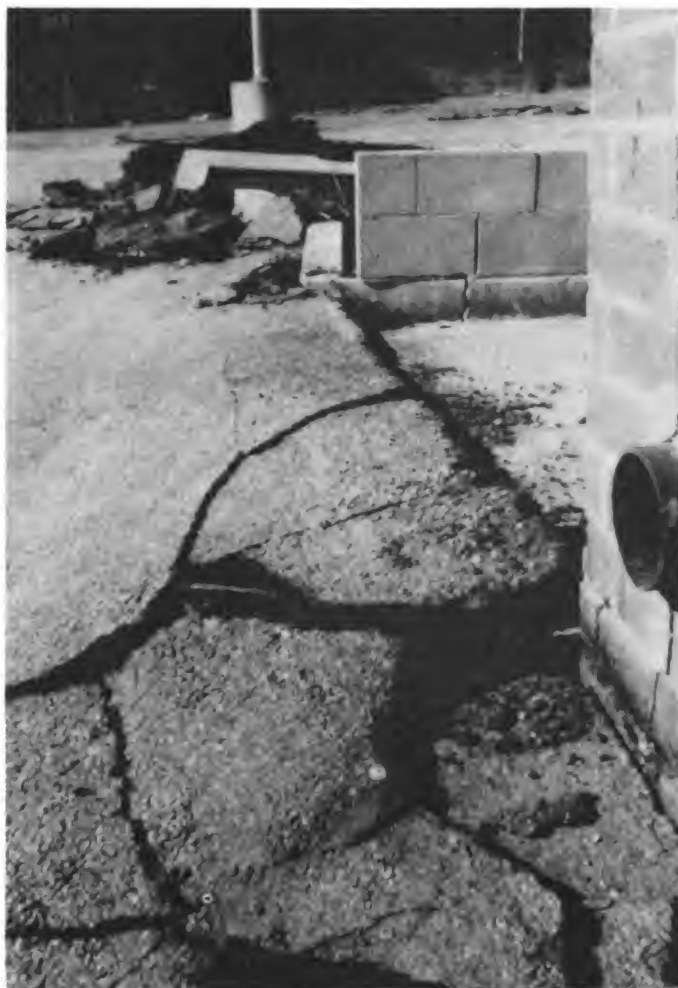
*Figure 5.—Southwest corner of bowling center. Looking west, approximately 100 feet east of Boys Market. Area ground movement. Note offset in curb in near background. LeRoy Crandall & Associates photograph.*

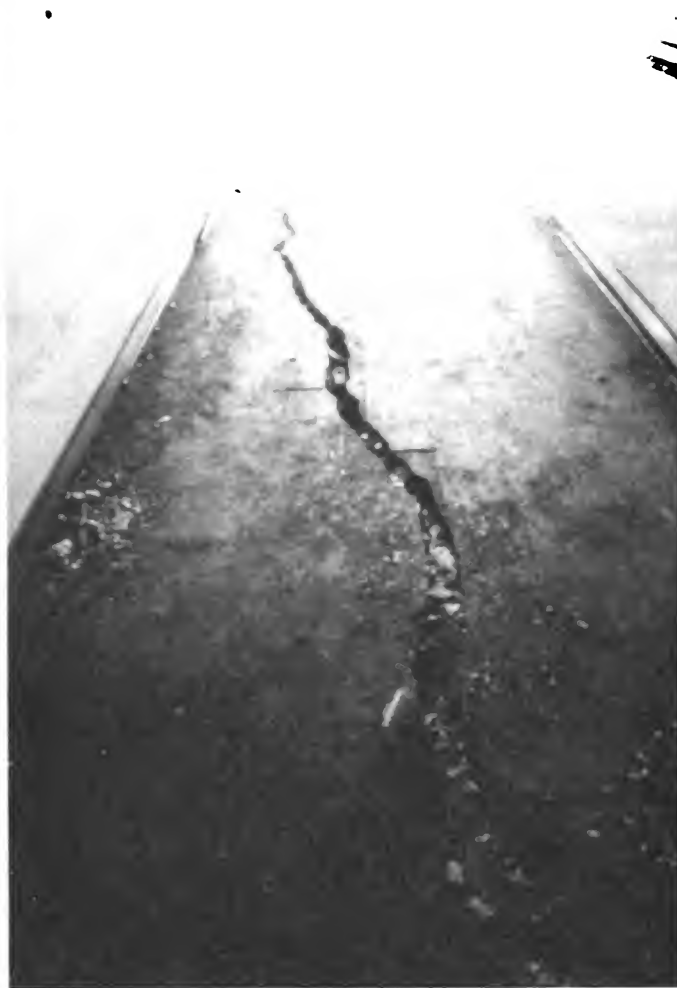
*Figure 6.—Boys Market. Typical north-south crack in building floor. LeRoy Crandall & Associates photograph.*

The market building floor was cracked badly. One of the typical cracks is shown in figure 6. It was reported that the open cracks were in the range of 4 inches in width, with differential vertical displacement in the same range at several locations. All observed floor cracks were thought to be tension cracks.

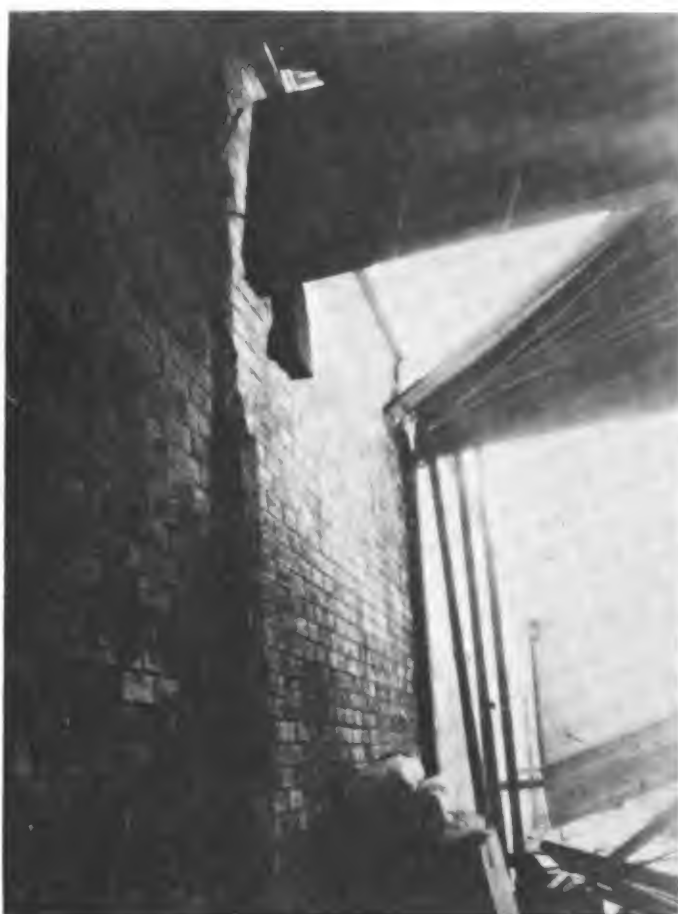
The masonry portion of the south wall, west of the loading dock, lost its lateral support during the earthquake and fell. The first bay of roof framing also fell to the ground. Figure 7 is looking toward the location of the south wall. Although the roof beams, rafters, and sheathings separated from the east wall, the wall remained in place. Figures 8 and 9 show how the beam seats along the east wall were torn apart. It was noted that approximately one-half of the ledgers bolted to the wall were ripped down.

Figure 8.—Boys Market. East wall, showing roof beams torn from their seats. LeRoy Crandall & Associates photograph.

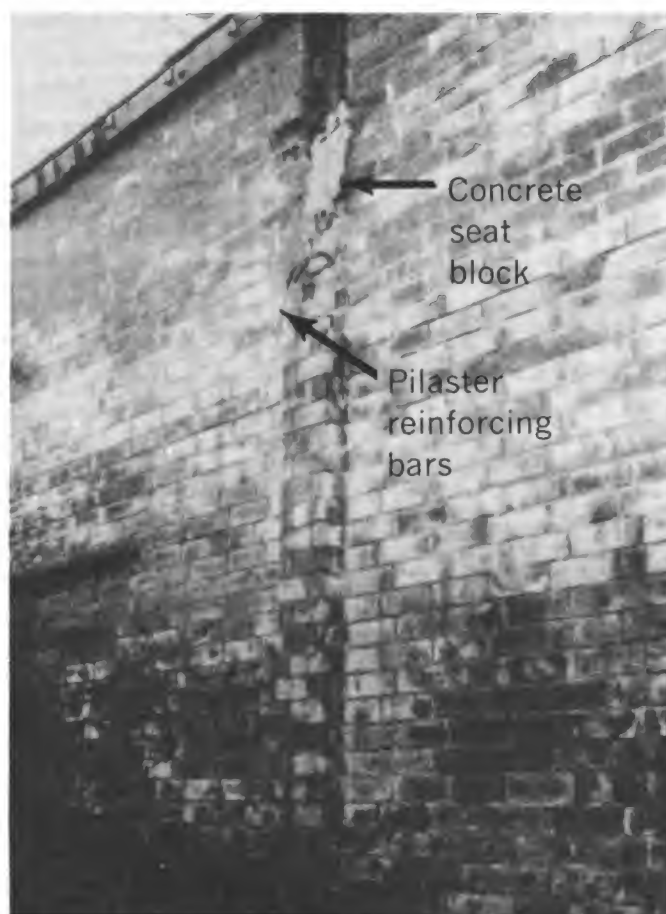
Figure 9.—Boys Market. Closeup of roof beam seat. Note broken concrete bearing block and reinforcing bars which are bent down the wall. LeRoy Crandall & Associates photograph.

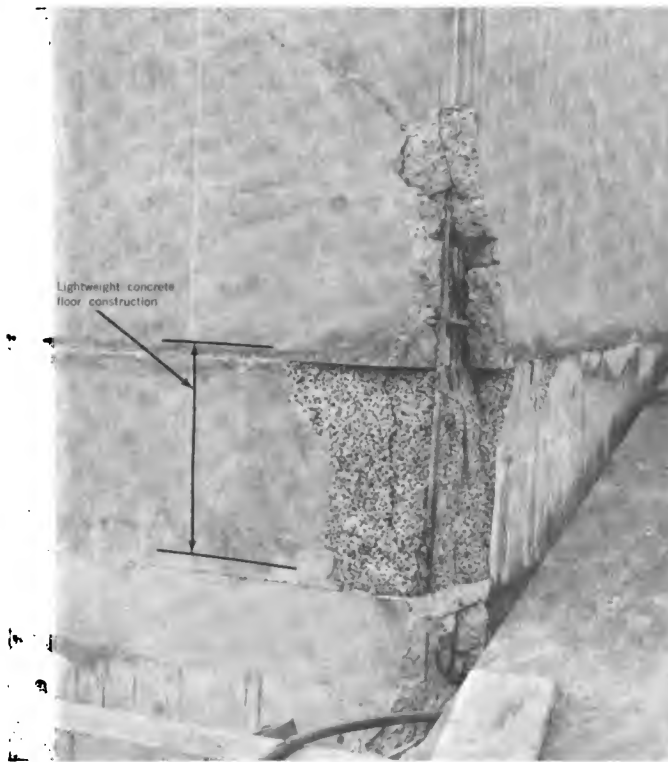
On the faces of the walls where differential movement took place, spalling was prevalent along the failure line. The spalling is apparent in figures 7 and 8. The typical No. 4 vertical wall reinforcing bars along the horizontal construction joint in the north and south walls were broken; many in the south wall were broken in two places. The broken bars were

Figure 7.—Museum for Antique Cars. Exterior northeast corner of museum building at first floor. Note lightweight concrete from slab extending through wall.

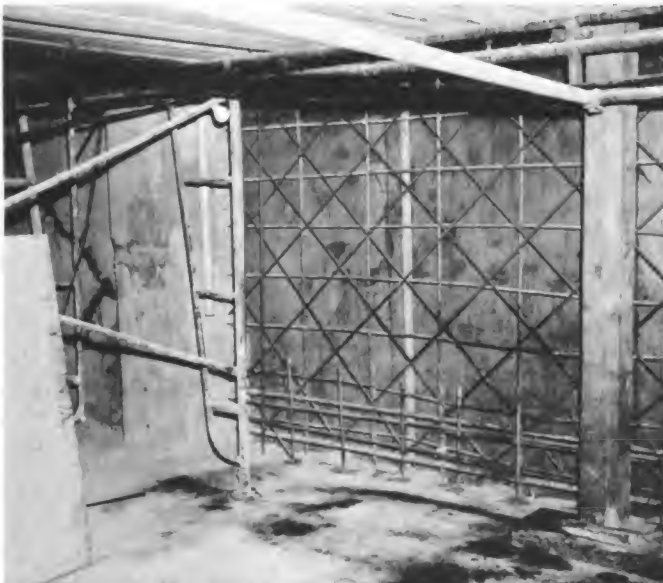
Figure 11.—Museum for Antique Cars. Reinforcing in place in wall panel to be replaced. Typical of north and south wall.

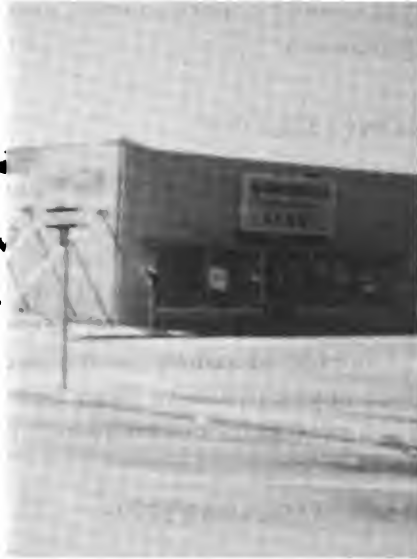
Figure 2.—Goodwill Industries. Precast walls are braced for safety following earthquake. J. Thompson photograph.

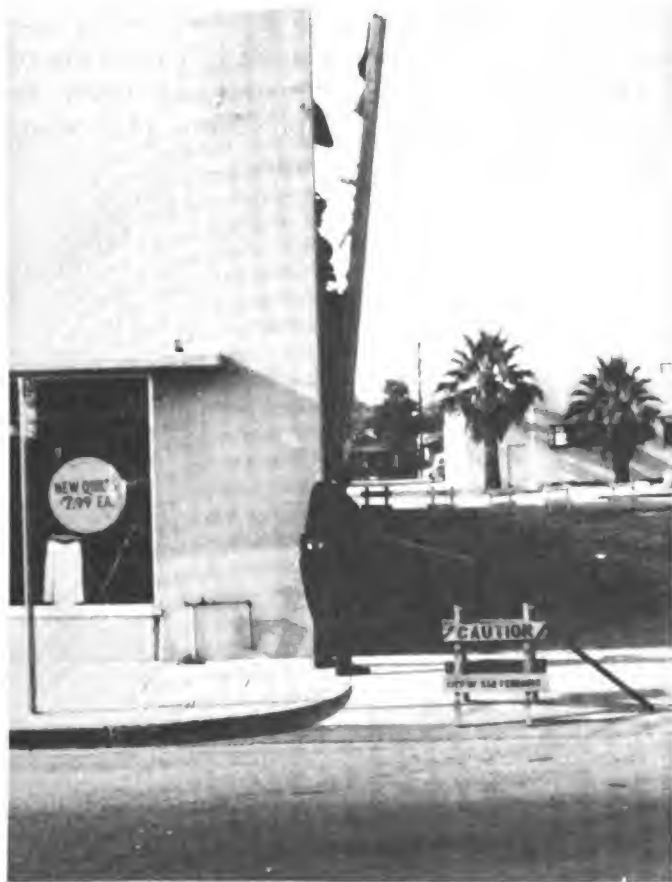
Figure 3.—Goodwill Industries. Precast panel leaning at front corner. Rudy Gunnarson photograph.

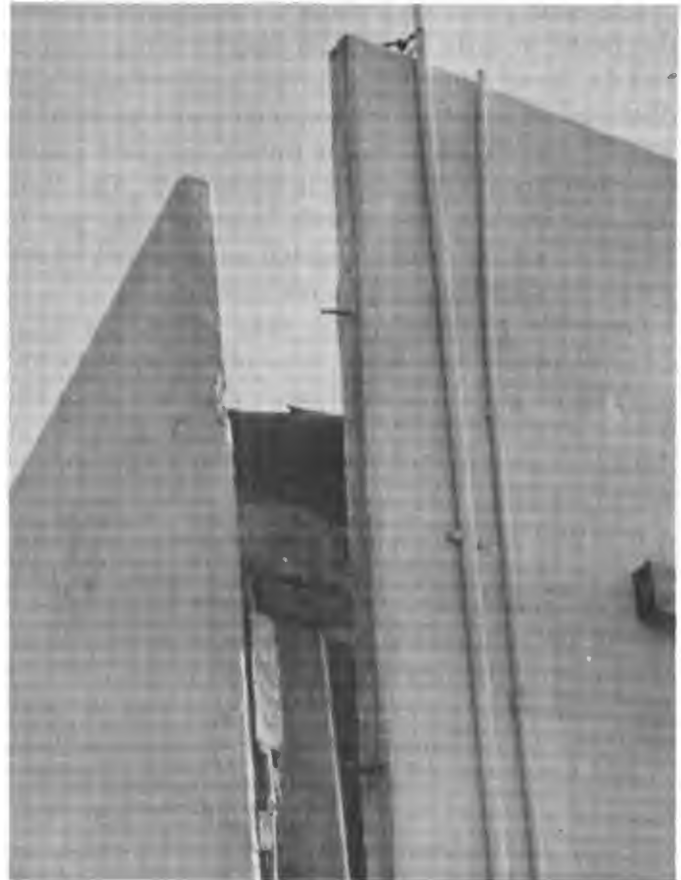
Figure 4.—Goodwill Industries. Northeast corner. Note short dowels from concrete wall. D. F. Moran photograph.

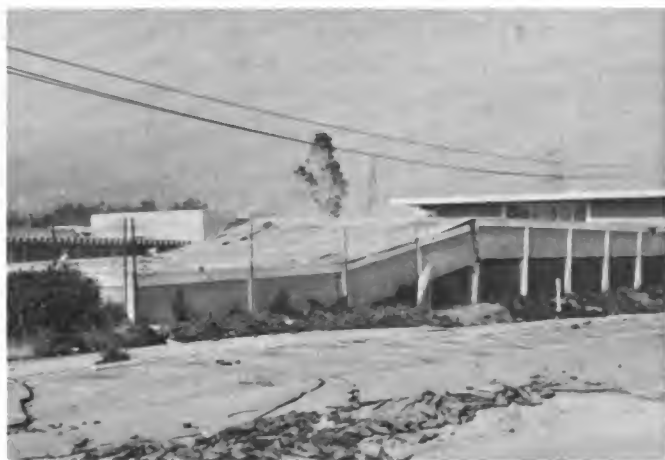
the northeast quadrant as indicated on the roof plan (fig. 2 and figs. 4 through 8). About 40 feet of block wall near the northwest corner and about 6 feet near the northeast corner collapsed under the falling roof. The principal north-south shear wall (12-in. block, stacked bond) was damaged very heavily, sustaining cracks from  $\frac{1}{4}$  to about 12 inches wide (figs. 3, 9, 10, and 11). Massive cracking occurred between the north end of the 12-inch wall and the first duct hole near the top of the wall, and along the top of the wall between duct holes. The north portion of

Figure 4.—San Fernando Valley Juvenile Hall. West wing of Administration Building, looking northeast.

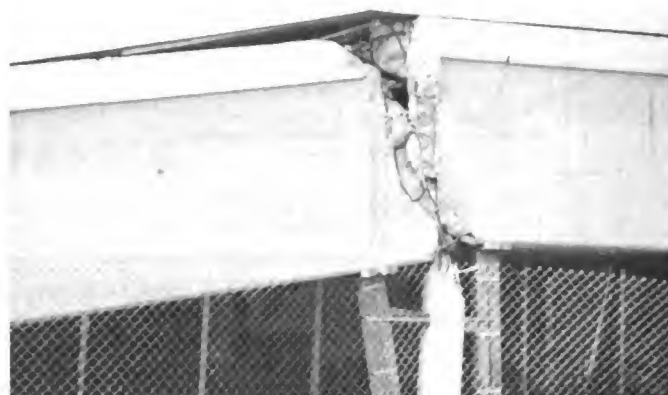
Figure 6.—San Fernando Valley Juvenile Hall. West wing of Administration Building. South wall line roof beam at main fracture line.

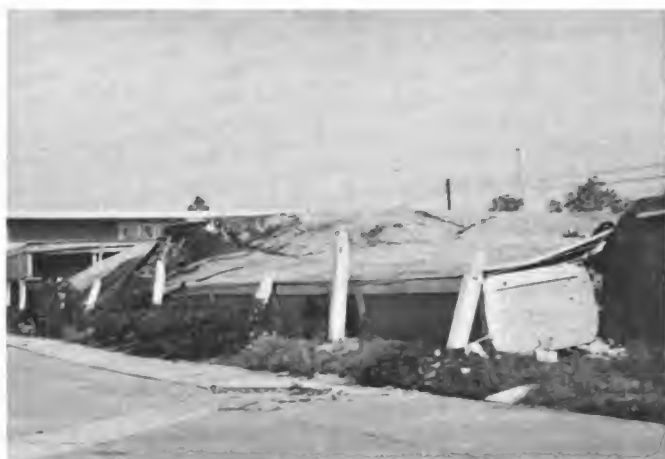
Figure 5.—San Fernando Valley Juvenile Hall. West wing of Administration Building, looking southeast.

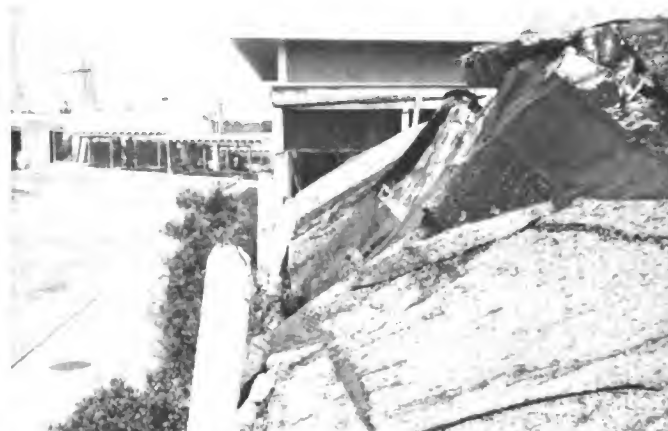
Figure 7.—San Fernando Valley Juvenile Hall, looking east along north wall line of west wing of Administration Building. Note concrete canopies in background.

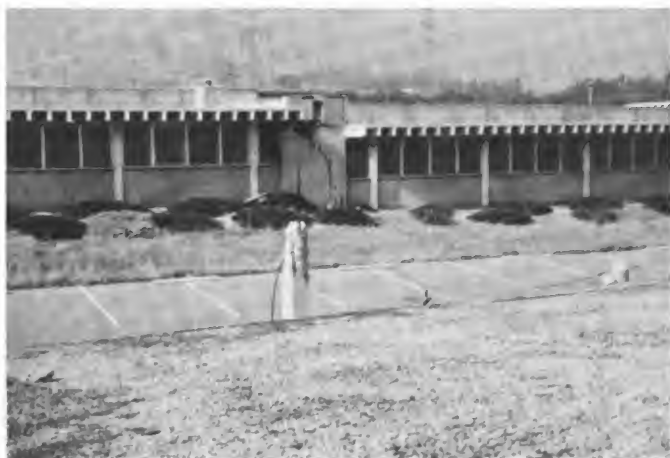
Figure 8.—San Fernando Valley Juvenile Hall, looking from roof of west wing of Administration Building, north toward living and receiving units.

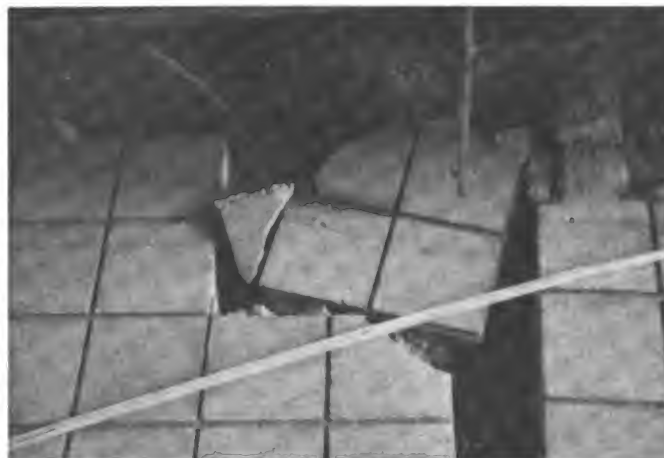
Figure 10.—San Fernando Valley Juvenile Hall. West wing of Administration Building. Massive cracking between duct holes in 12-inch block shear wall.

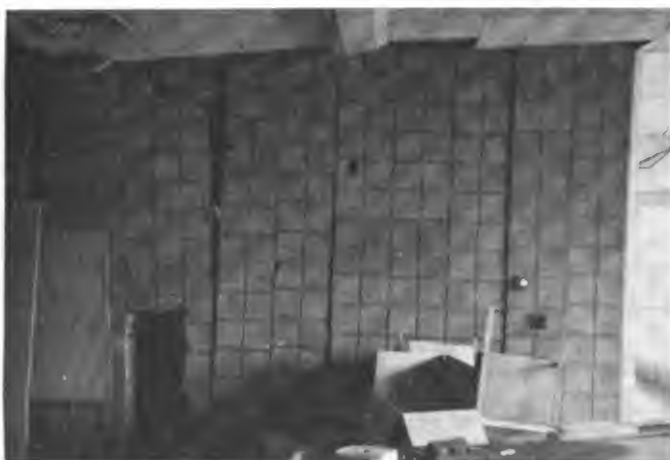
Figure 9.—San Fernando Valley Juvenile Hall. West wing of Administration Building, looking at south end of 12-inch block shear wall.

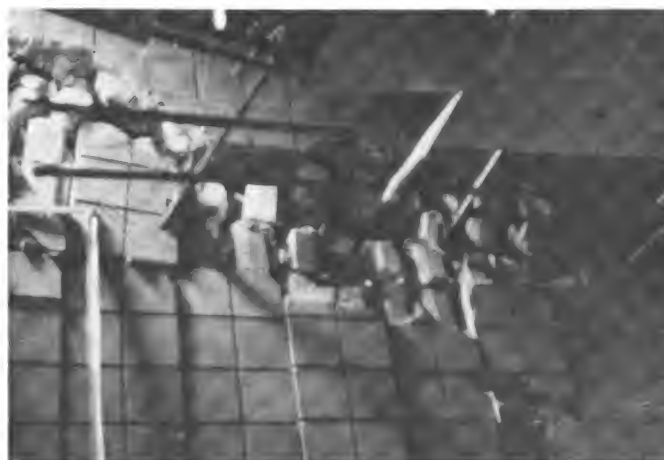
Figure 11.—San Fernando Valley Juvenile Hall. West wing of Administration Building. Massive cracking, near north end of 12-inch block shear wall, in line with duct openings.

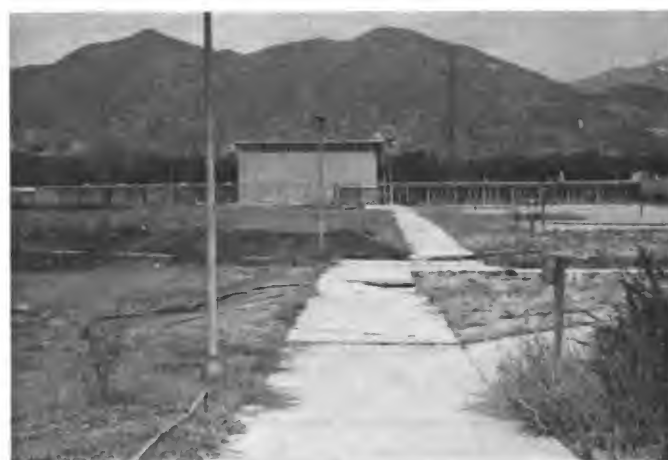
Figure 15.—San Fernando Valley Juvenile Hall. Boys' school and gymnasium, looking north at gym and two classroom wings. Note ground ruptures in foreground.

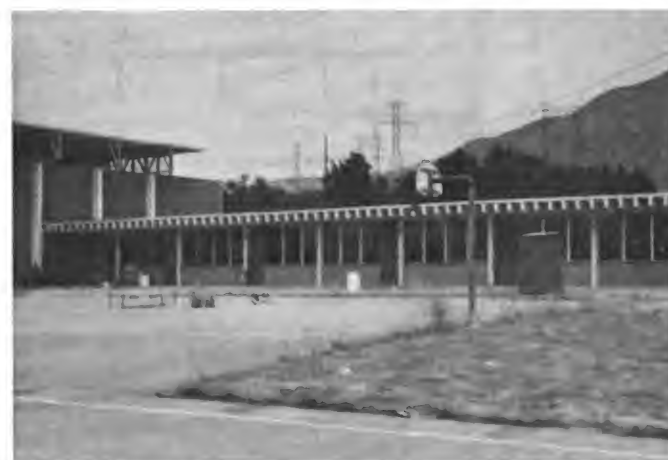
Figure 16.—San Fernando Valley Juvenile Hall. Boys' school and gymnasium, looking north at east wing of classroom building. No significant damage.

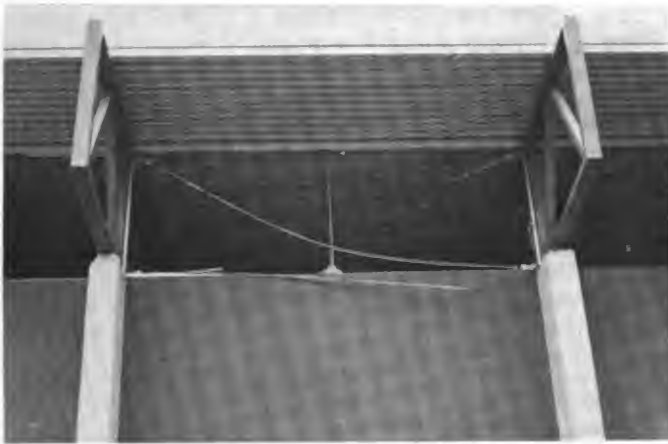
The east wing of the classroom buildings received no significant structural damage (figs. 15 and 16). The gymnasium portion was damaged in the upper framing where the steel roof deck seismic forces are transferred into the concrete walls. Diagonal steel rods in the east and west upper windows were damaged heavily (fig. 17). About half of the rods (7 or 8) were ruptured completely, usually at the threaded connection, and the remaining rods were stretched extensively. The upper window glass was broken out at the east and west walls. The connection of the diagonal rods at the top of the concrete wall was fractured where it is intersected by the bottom of the truss (figs. 18 and 19). Concrete was cracked and spalled on most of these connections along the east and west walls. The diagonal rods at the north and south wall clerestory were not broken or significantly stretched. One rod at the west end of the south wall was stretched slightly so that the sag was noticeable. No sagging was observed at the other rods. Windows were not broken at the north and south wall windows. The gym east wall (8-in. concrete) has diagonal cracks up to  $\frac{1}{8}$  inch in width on each side of the north door and a vertical crack, about  $\frac{1}{8}$  inch wide, over the south door (fig. 17). The gym west wall has larger cracks, up to about  $\frac{1}{4}$  inch wide, in the north bay between the first two exterior columns (figs. 18 and 20). Some vertical cracking also occurred in this bay. Generally, the gym portion of the building received very light damage, except at the

Figure 17.—San Fernando Valley Juvenile Hall. Boys' school and gymnasium, east wall of gym. Failed rod bracing.

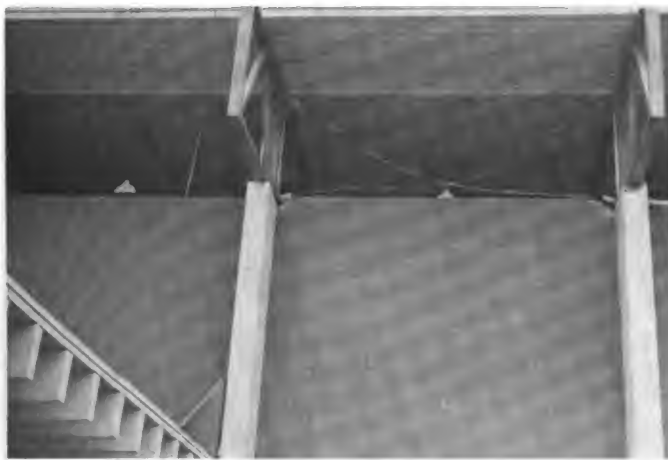
Figure 18.—San Fernando Valley Juvenile Hall. Boys' school and gymnasium, west wall of gym. Failed rod bracing and cracks in concrete wall panel.

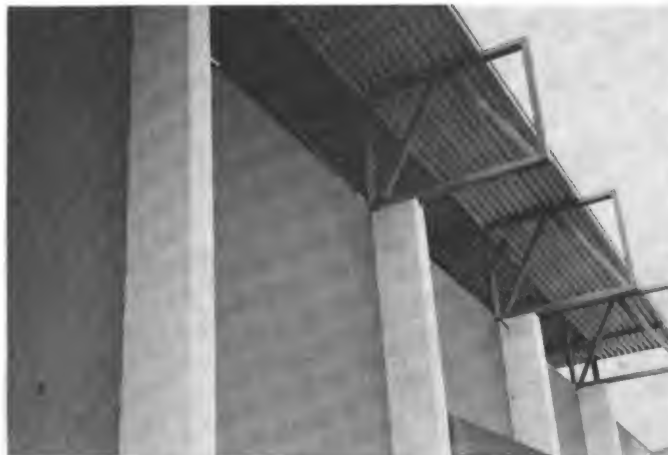
Figure 19.—San Fernando Valley Juvenile Hall. Boys' school and gymnasium, east wall of gym. Note cracks and spalling in concrete column.

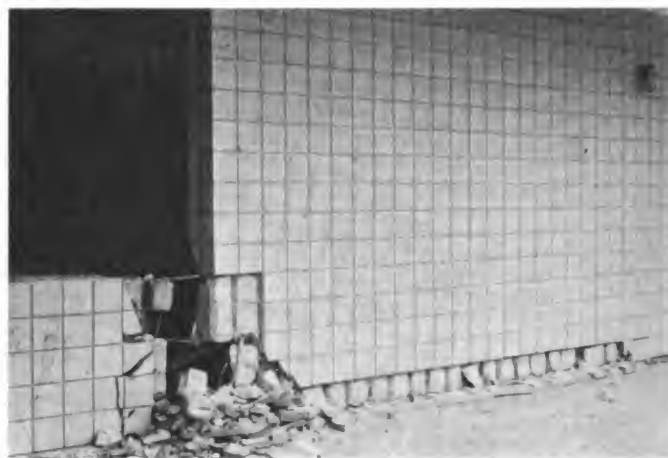
**Figure 23.**—San Fernando Valley Juvenile Hall. Boys' school and gymnasium. West shear wall of boys' classroom. J. F. Meehan photograph.

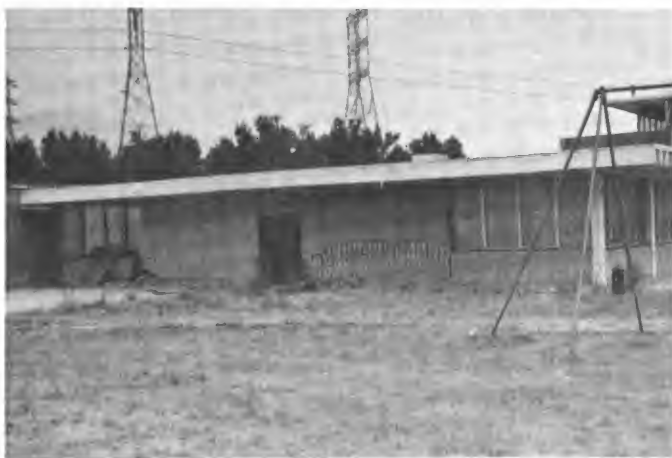
The west wing of the classroom building was damaged quite heavily at the west-end wall. The 12-inch block shear wall on both sides of the door sustained extensive fractures (fig. 21). The pier on the south side of the door was shattered, causing a large portion of the face shells of the blocks to spall off. Diagonal cracking up to about  $\frac{1}{2}$  inch wide occurred. The bottom corner of the wall pier (north side) was cracked heavily and was spalled and broken out in an area about 12 by 24 inches in size. Vertical jamb bars were exposed (fig. 22). The pier on the north side of the door was damaged; block face shells spalled off along the bottom course of the masonry units (fig. 23). The masonry wall spalled at the bottom corner at the south side of the pier, exposing jamb reinforcing (fig. 24). The interior 8-inch block wall also was ruptured at its juncture with the north pier. At the north end of the pier, an area of about 4 feet high and 5 feet wide was broken out completely (fig. 23). The 12- by 20-inch reinforced concrete bond beam over the door was completely ruptured. It sustained a diagonal crack 2 to 4 inches wide and local spalling. The parallel joists at the roof overhang also were fractured at this point with diagonal cracking (fig. 25).

**Figure 21.**—San Fernando Valley Juvenile Hall. Boys' school and gymnasium. West wall of west classroom wing.

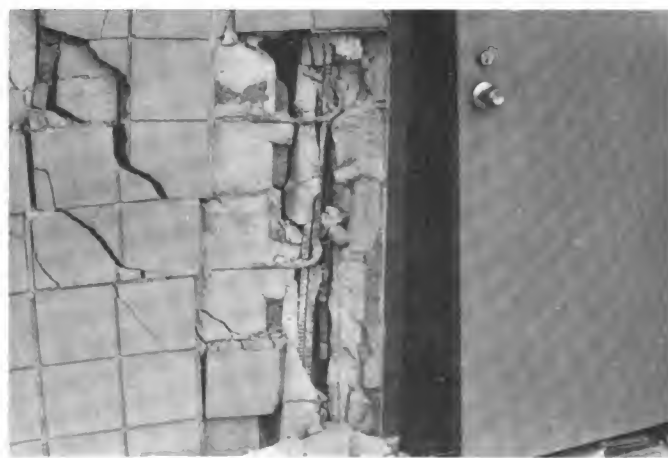
**Figure 24.**—San Fernando Valley Juvenile Hall. Boys' school and gymnasium. West wing shear wall. J. F. Meehan photograph.

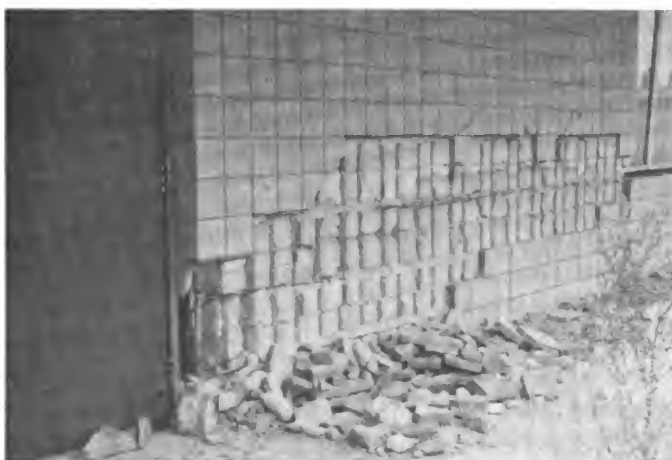
**Figure 22.**—San Fernando Valley Juvenile Hall. Boys' school and gymnasium. West wall of west classroom wing.

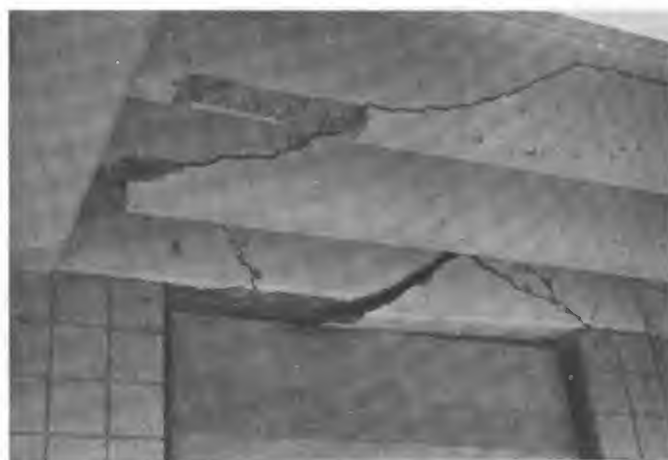
**Figure 25.**—San Fernando Valley Juvenile Hall. Boys' school and gymnasium. Concrete bond beam over door at west wall of west wing.

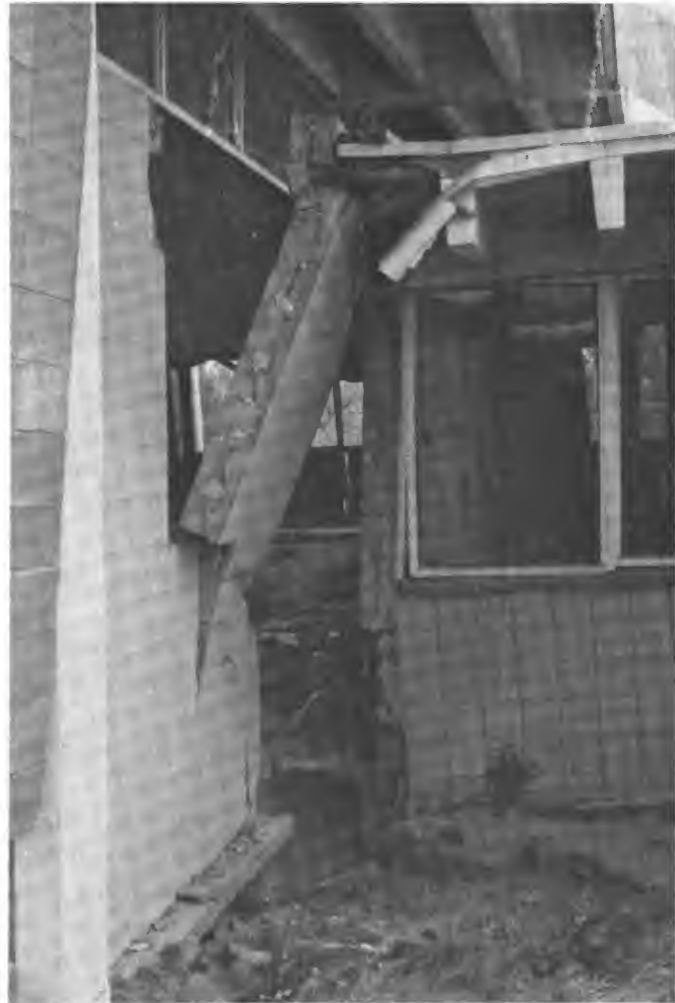
Figure 26.—San Fernando Valley Juvenile Hall.  
Ground rupture at building.

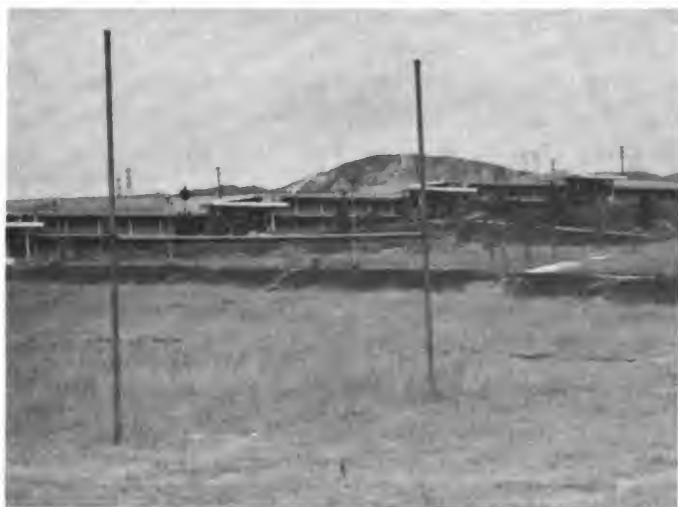
Figure 27.—San Fernando Valley Juvenile Hall. Ground rupture in foreground. Living units E in background.

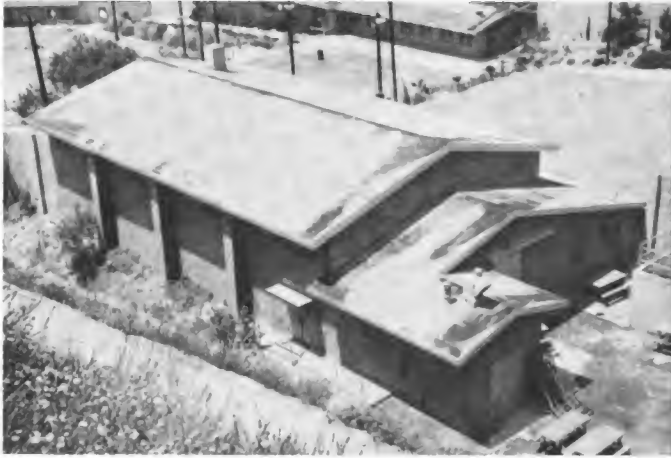
**Figure 4.**—Camp Karl Holton Juvenile Facilities. Recreation building, looking southwest.

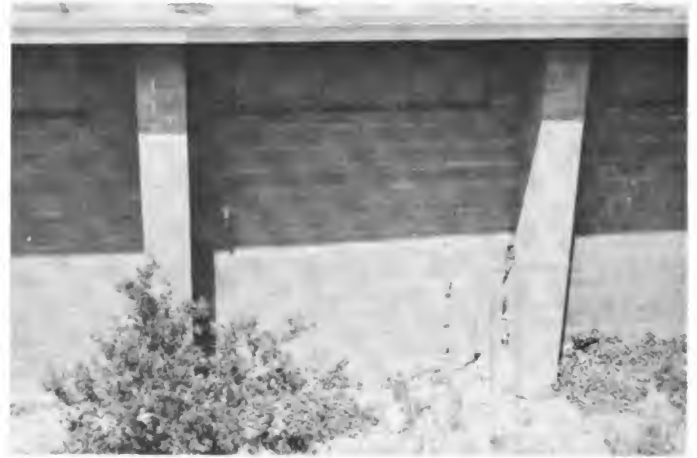
**Figure 6.**—Camp Karl Holton Juvenile Facilities. Recreation building. Large crack in east wall.

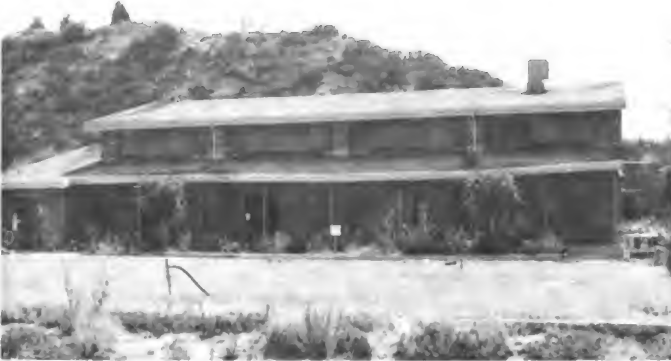
**Figure 5.**—Camp Karl Holton Juvenile Facilities. Recreation building, looking east.
